Manhole Inspection Summary

Manhole # S53AA_011MH

Location Address: **Robinson- Ellwood**

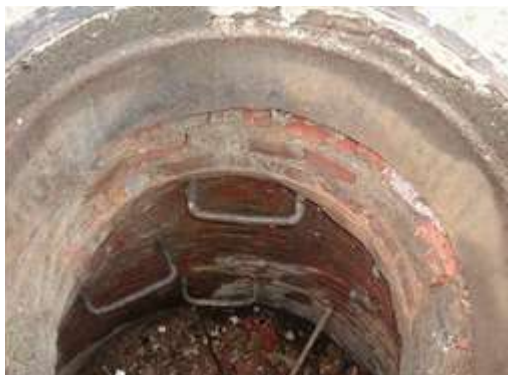
Defect 2

Frame Offset: **2** (in.) Condition: ☐ Sound ☐ Cracked ☒ **Leaks**

Frame Leaks

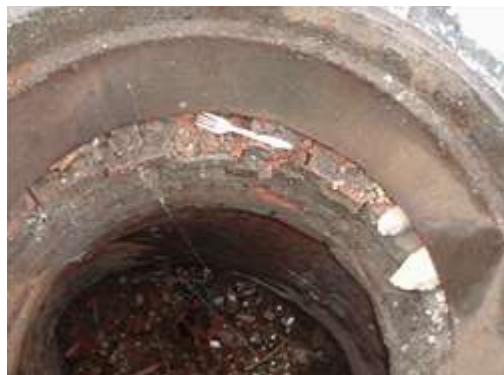
Defect 1

Offset

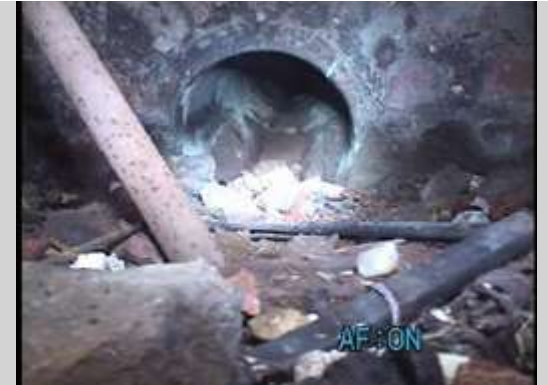
12 O'Clock Outflow

8 in. Circular Gravity Sewer
Pipe Out @ 12 O'Clock
